Manhole Inspection Summary

Manhole # S37C__049MH

Insp Date: **10/20/08 9:24 AM**

Location Address: **410 front st**

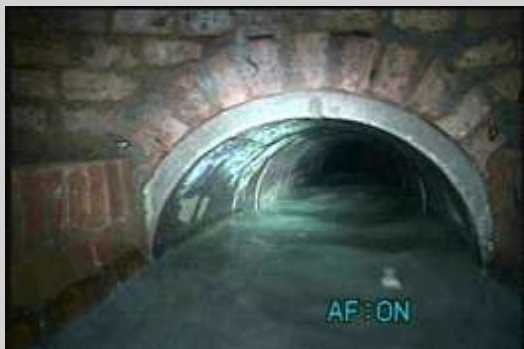
6 O'Clock Inflow

21 in. Circular Gravity Sewer
Pipe In @ 6 O'Clock

Pipe Material: **Clay** ☐ Pipe Lined

Infiltration: **None** Pipe Seal Cond: **Unknown**
